TEST OF AN ELECTROHYDRAULIC DIGITAL ACTUATOR FOR ADVANCED MISSILE SYSTEMS

TECHNICAL REPORT AFWAL-TR-80-2001

Final Report for Period September 1978 - September 1979

BENDIX RESEARCH LABORATORY
REPORT OF REACTION PIN SPACER
FAILURE

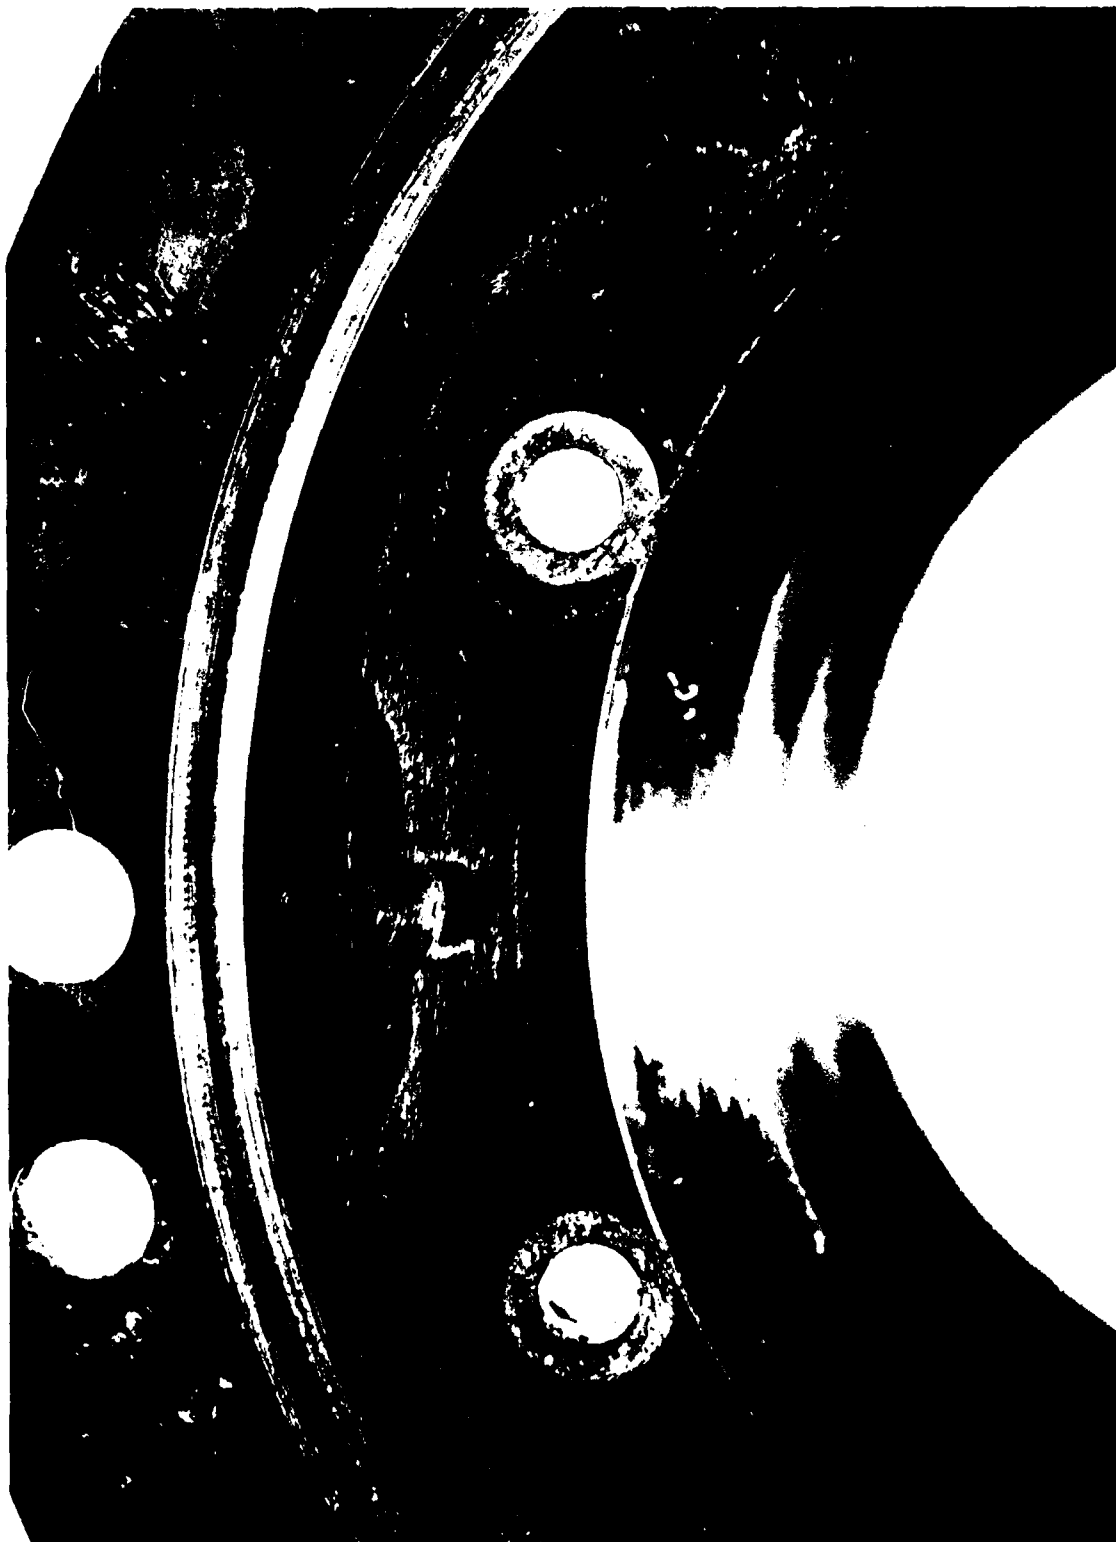
Figure 20. Actuator Housing

At the end of the life test, the actuator was disassembled and inspected. The number one reaction pin spacer, shown in Figures 16 and 17, was broken into four pieces. Reaction pins are shown in Figures 18 and 19. The other reaction pins and other parts of the actuator, as shown in Figures 20 through 23, appeared to be in good condition. The pieces of the broken pin all had sharp edges and showed no sign of being crushed. The magnetic plug was clean after the 50th hour.

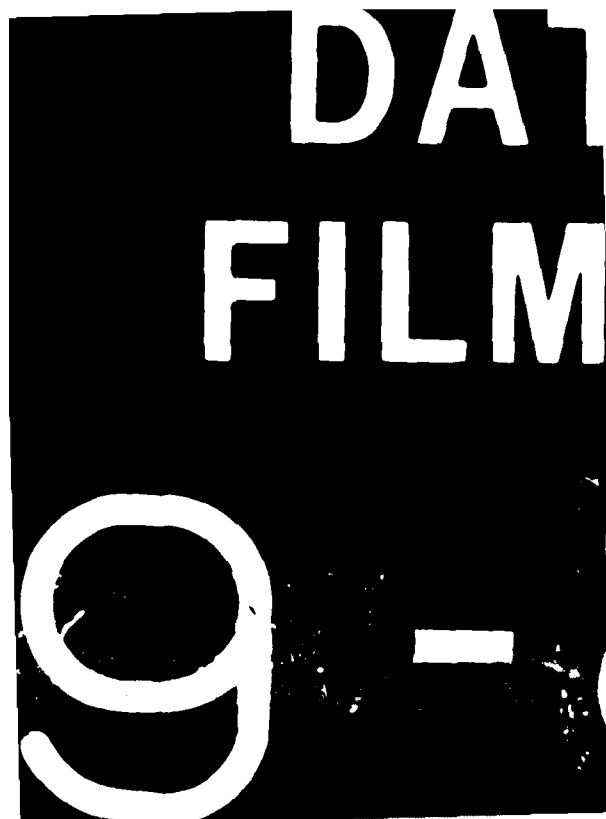
Figure 20 con't. Longitudinal and cross sections through one of the provided pin-spacers which sustained the life test with no failure.

- Figure 20. cross section of the spacer as etched, showing a uniform microstructure with no visible cracks.

Longitudinal section through a pin spacer which did not fail during the life test, showing neither metallurgical nor manufacturing defect.
